USE OF SONIC TOMOGRAPHY TO DETECT AND QUANTIFY WOOD DECAY IN LIVING TREES¹

- *Premise of the study:* Field methodology and image analysis protocols using acoustic tomography were developed and evaluated as a tool to estimate the amount of internal decay and damage of living trees, with special attention to tropical rainforest trees with irregular trunk shapes.

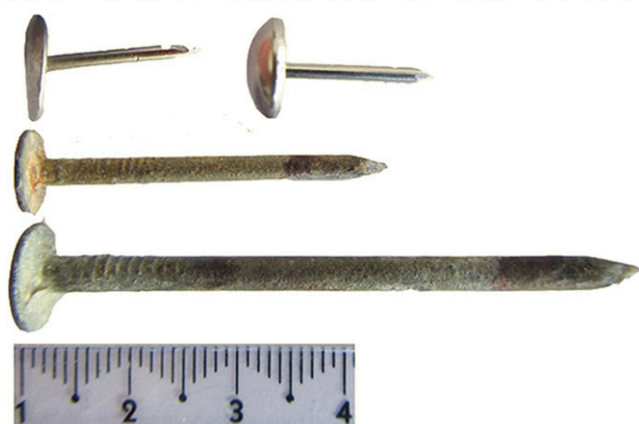
Fig. A3-2. Examples of nickel upholstery nail (top, with head intact [right] or flattened for better sensor contact [left]) for thin-barked tree species, and larger steel roofing nails (middle and bottom) used for thick-barked tree species.

2. Nails must be magnetic (i.e., steel or nickel, but not aluminum) and have a broad, flat head (Fig. A3-2). For thin-barked trees, we use nickel upholstery nails (National Hardware V7730 N279-174) and flatten the heads with a mallet. For thicker-barked trees, we use short steel roofing nails (but with large heads) that penetrate to the wood. It is best to have a number of nail sizes available and use the smallest nail practical to minimize damage to trees; each nail just needs to pass through the bark to make solid contact with wood.
